# ARCHAEOLOGICAL CURATION-NEEDS ASSESSMENTS Technical Report No. 4

Mandatory Center of Expertise for the Curation and Management of Archaeological Collections

4. TITLE AND SUBTITLE	•		5. FUNDING NUMBERS
		•	
An Archaeological Curation-Needs	Assessment for Fort Rile	y, Kansas	
		·	
6. AUTHOR(S)		,	`
Charles M. Slaymaker and Natalie N		ble and	
Christopher B. Pulliam, Series Edit	ors)

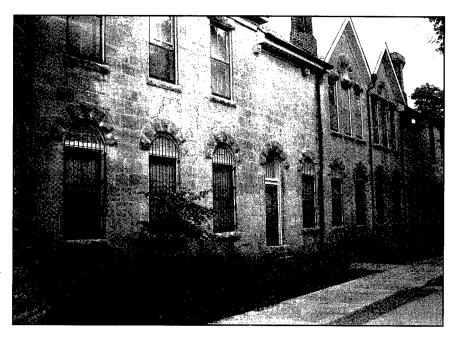
Numerous windows (Figure 3) face in all directions on the three floors. On the first floor, 10 windows face north (four are blocked from the inside), 14 face west (all are blocked from the inside), six face south (five are blocked from the inside), and nine face east (four are blocked from the inside). All windows on this floor are covered with steel bars. On the second floor, 10 windows face north

Figure 3. View of Cavalry Museum windows.

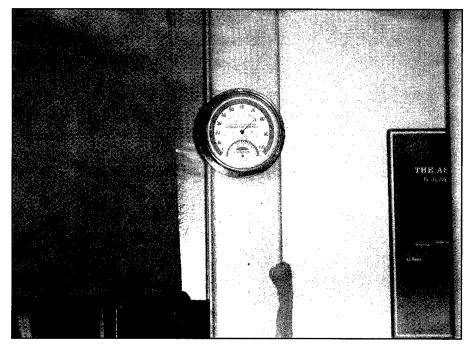
Repository 2 has central heating and cooling and is monitored regularly. Humidity and temperature levels are kept within the standards set by the American Association of Museums and are monitored with a recording hygrometer (Figure 5). Recessed fluorescent lights with UV filters provide illumination.

Figure 5. Environmental monitoring device in Repository 2.

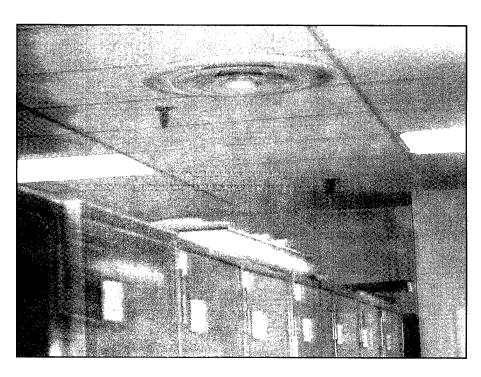
Repository 2 has a wet-pipe sprinkler system (Figure 7) in the suspended acoustical tile ceiling. There are at least two fire extinguishers with up-to-date inspection tags.

Figure 7. Sprinkler system in Repository 2.

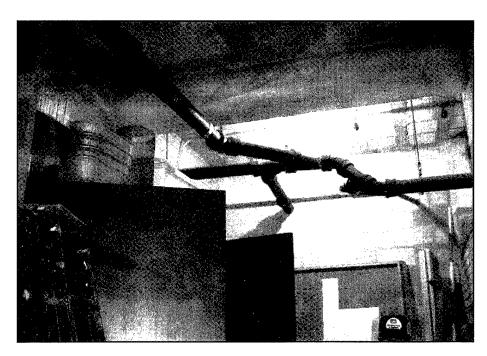
Rooms 10 and 11 are neither heated nor cooled. Humidity controls and environmental monitoring are absent. Lighting is provided by incandescent fixtures. Rooms 10 and 11 (Figure 9) are more environmentally stable than Room 301A. However, the damp and cold conditions in the winter would adversely affect the containers, labels, and bottles.

Figure 9. Ceiling in Burt Hall Rooms 10 and 11. Note sewer pipes directly over the wood cabinet where the Fort Riley whiskey bottle collection is curated.

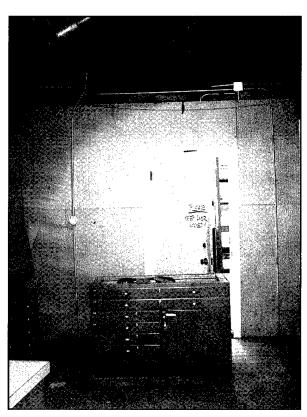
The single, exterior door on Room 301A has a dead-bolt lock (Figure 10), but because of the isolated nature of the repository, security could be compromised. The single window is secured with a standard sash lock and the only access is by ladder. University police regularly patrol the exterior vicinity of the building, but the isolated nature of the repository—in essentially a dead-storage area—makes forced entry from inside the building possible.

Figure 10. Entrance to attic storeroom—Room Figure 11. Metal door leading to Rooms 10 and 11.

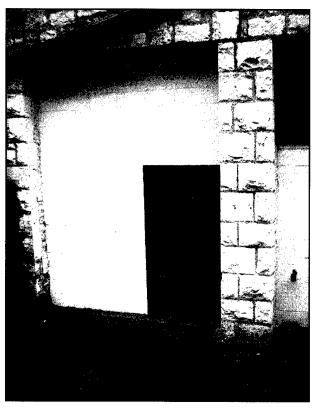
The door on Rooms 10 and 11 has a dead-bolt lock, and there are no windows. A solid metal door leads to the exterior (Figure 11). University police regularly patrol the area.

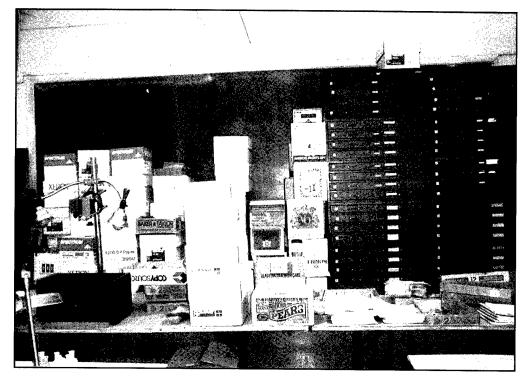
Figure 12. Primary containers in Willard Hall. Note the cabinet on the right, which houses some of the Hospital Latrine Collection.

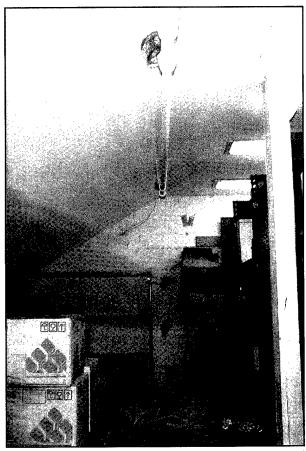
Two types of storage units contain the Fort Riley archaeological collections. One unit (Figure 13) has an enameled-steel frame with untreated plywood shelves and is 48 in long, 14.75 in wide, and 75 in high. A second type, consisting of 12 units, has an enameled-steel frame with enameled-steel shelves and is 36 in long, 24.5 in wide, and 96 in high (Figure 14). Fort Riley collections fill 12 shelving units and part of a thirteenth. Ninety percent (90%) of this space is presently in use. No labels have been placed on the shelves. Boxed artifacts are stacked one box high on most shelves. Some shelves contain smaller boxes that are stacked two-to-three boxes high.

Figure 13. Enameled-metal frame with wood shelves storage unit (background) in Room 301A.

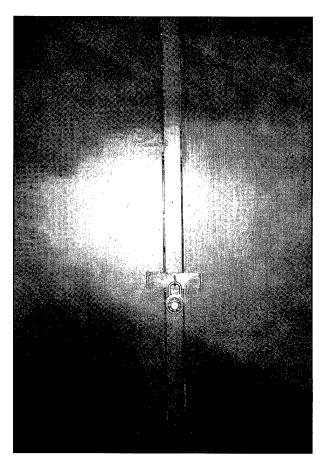
Artifacts in Rooms 10 and 11 are stored in a padlocked wood cabinet (Figure 15) with two doors and six shelves. The cabinet is 72 in high, 48 in wide, 36 in long (deep). The cabinet and shelves are treated with varnish.

Figure 15. Locked wood cabinet in the basement of Burt Hall.

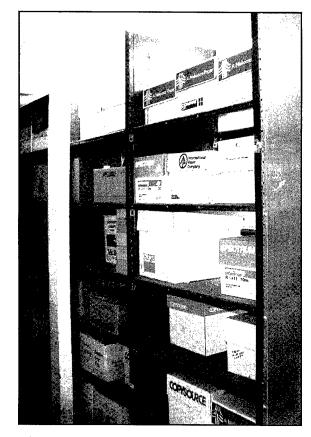
Acidic cardboard boxes of various sizes (Figure 16) hold collections. Boxes containing bottles are reused liquor and glass-jar boxes with cardboard inserts. Many of the additional boxes are reused acidic computer/copy paper boxes. Most of these boxes, with the exception of the leather collection, have no consistent label information. Some boxes have numbers or material class information recorded directly on the box in marker. Each box of the leather collection has a box inventory in an envelope that is attached with acidic strapping tape.

Figure 16. Various-sized primary containers in Room 301A.

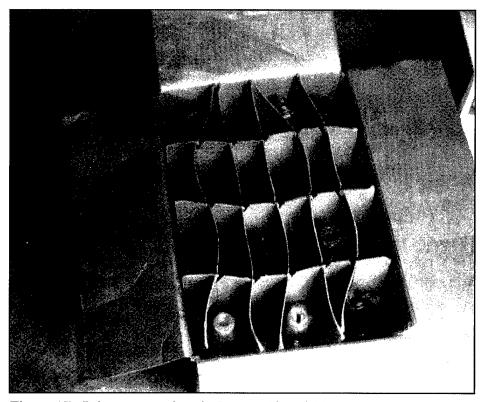
Artifacts are stored in reused flap-fold liquor boxes with cardboard dividers (Figure 17). Boxes are unlabeled.

Figure 17. Primary container in Rooms 10 and 11.

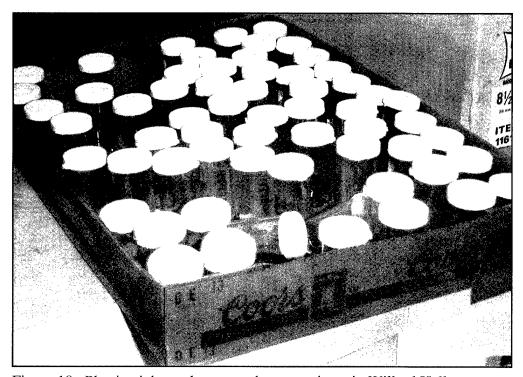
Figure 18. Plastic vials used as secondary containers in Willard Hall.

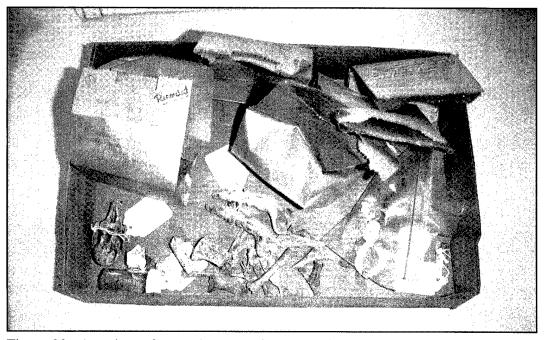
Figure 20. A variety of secondary containers used in Room 301A.

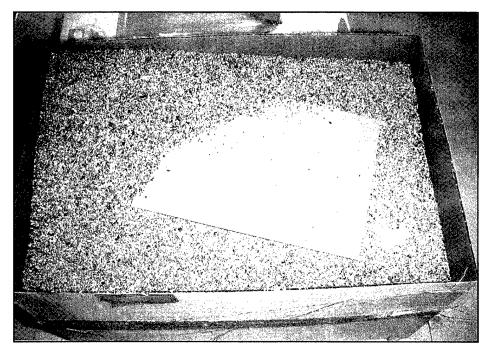
Figure 22. Storage of leather surrounded by muslin and packed with vermiculite in Room 301A.

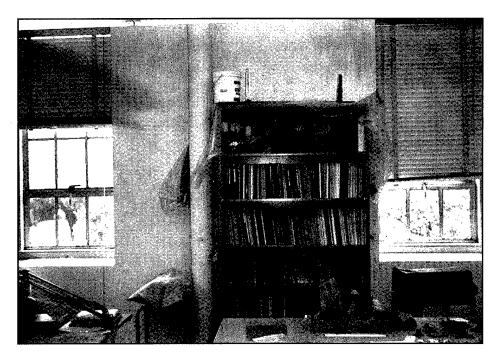
Approximately one linear foot of associated documentation is stored in a Hollinger box on a metal shelf in Willard Hall (Figure 23). Approximately one-half of a linear foot of associated documentation is stored in an acidic expandable file on the shelf (Table 3).

Primary containers are unlabeled. Associated documentation is in poor condition. Tears and abrasions were present on many of the documents, and the newspaper documents are discolored and brittle.

Figure 23. Fort Riley associated documentation is stored on the top shelf of a metal bookshelf in Willard Hall.

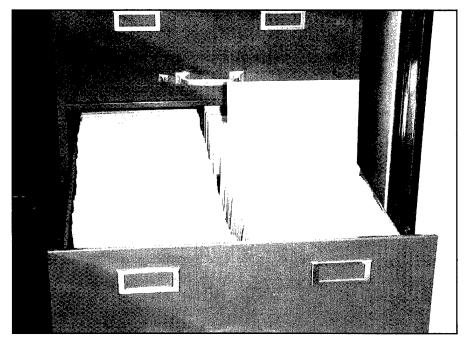
Approximately 10 linear inches of four-by-eight-inch index cards serve as the primary catalog for the Hospital Latrine artifacts. The cards contain typed information, including catalog numbers, artifact descriptions, provenience, and notes. The cards are stored in a standard four-by-eight-inch, metal card file in Willard Hall (Figure 24). The cards are in good condition but are beginning to show wear. The paper stock is discolored due to the acidity of the paper.

Figure 24. Artifact catalog in Willard Hall.

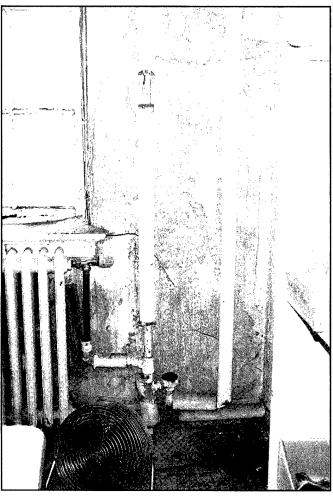
Interior walls of the repository are made of plasterboard, and the floor is poured concrete covered with linoleum. Exposed water pipes cross two walls and the ceiling. Former water leaks from one pipe stain one wall and the ceiling. One wood, double-hung window faces east. A radiator is located under the window (Figure 26). One solid wood exterior door faces west.

The conservation laboratory has steam heating and no air conditioning. Temperature and humidity are not monitored. At the time of the visit, portable fans were set up to provide air circulation. Shades are not present on the windows. Lighting is by fluorescent lights without UV protection.

Figure 26. Damage caused to the wall by extreme environmental conditions in the collection storage area in Henrian Hall.

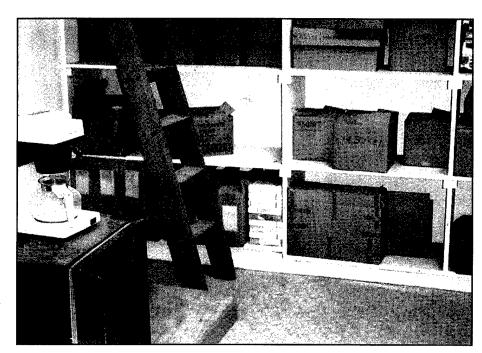
Artifacts are stored in acidic shoe boxes of three sizes (Figure 29)—three boxes are 13 in by 6.5 in by 2.75 in; two boxes are 13 in by 6.5 in by 2.5 in; and three boxes are 13.5 in by 6.75 in by 1.5 in.

Figure 29. Fort Riley collections are stored on the lowest shelf on the left.

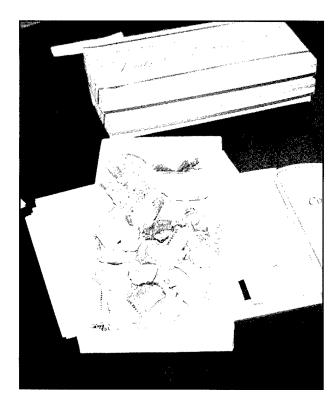
Secondary containers include paper bags (36%) and plastic bags (14%) (Figure 30). Some artifacts are stored loose in the primary container (50%) (Figure 31).

Figure 31. Fort Riley artifacts stored loose in a primary container.

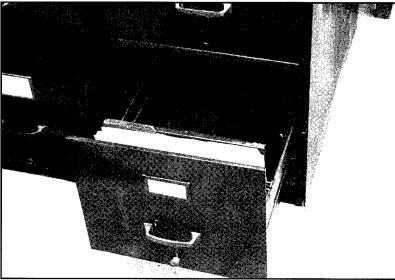
Paper records are stored in one drawer of a standard four-drawer metal file cabinet (Figure 32) in Henrian Hall. Associated documentation measures less than one linear foot (0.5). Approximately 25% of the documentation is administrative records, 25% is a combination of excavation and analysis records, and 50% is report records.

Figure 32. Fort Riley documentation is curated in a metal file cabinet in Henrian Hall.
